LATER ALTERATIONS

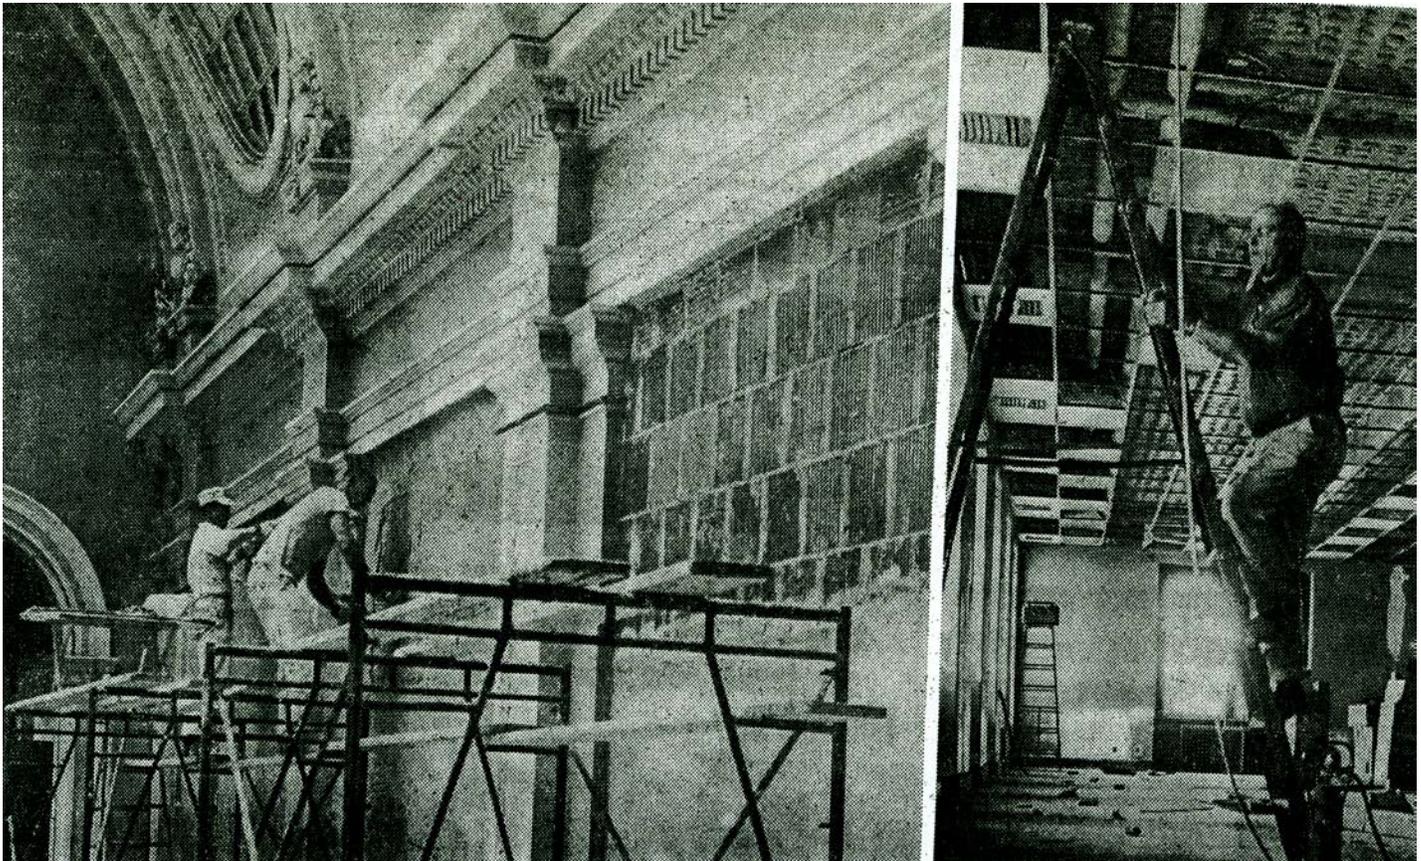
THE FOURTH FLOOR CORRIDOR COLONNADE BEING WALLED-IN AND NEW SUSPENDED CEILINGS IN THE OFFICES, 1962

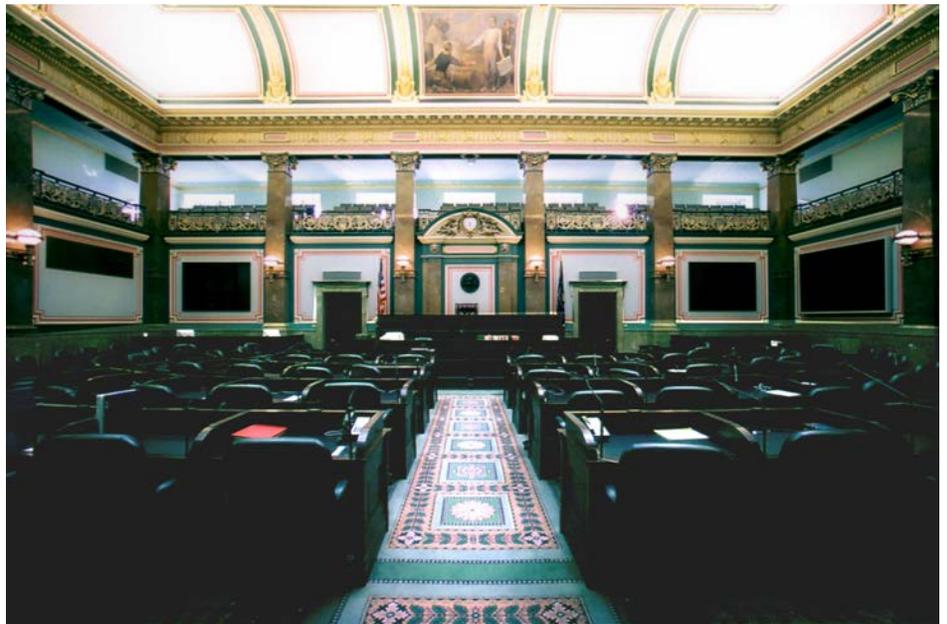
HOUSE OF REPRESENTATIVES CHAMBER WITH MODERN COLORS
