SPECIFICATIONS AND PLANS REFLECT THE COMMISSION'S DESIRE TO MAKE THE BUILDING A STATE MONUMENT

THE USE OF CONCRETE: A MODERN TECHNOLOGY

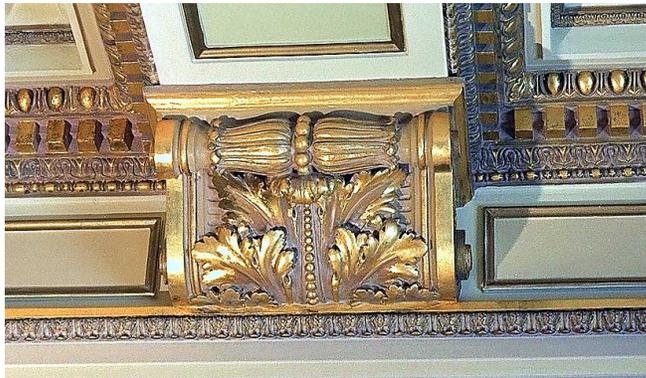
GOLD LEAF IN THE GOLD ROOM

Gold leaf was used extensively on interior detailing—23 karat on ceilings, sofas, chairs; 14 karat on ceiling decorations. Gold leaf also was used on tables and chairs, gold thread in wall tapestries and two gold-backed mirrors. In the Gold Room there were wall tapestries and green brocade chairs from Italy which had 14 karat gold thread. Steel doors, steel and glass doors and heavy brass doors were on the exterior entrances; wooden window frames were routine throughout the building.⁷² Kletting approved the use of a dark grey paint for painting the exterior window frames and inside white enamel.⁷³

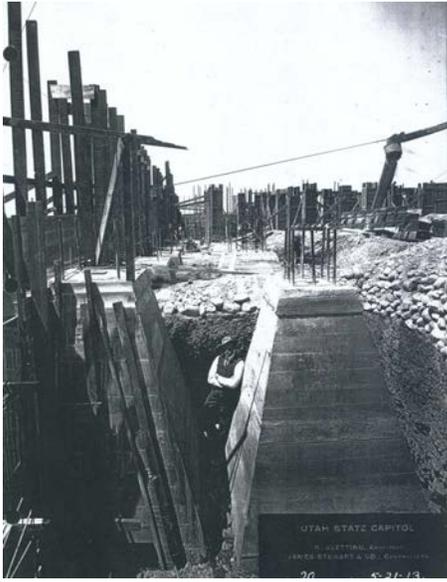
EXCAVATION FOR INSPECTION OF REINFORCING

Before any concrete was laid, the architect had to be notified so he could inspect the steel and insure proper mixing of the concrete.⁵⁸

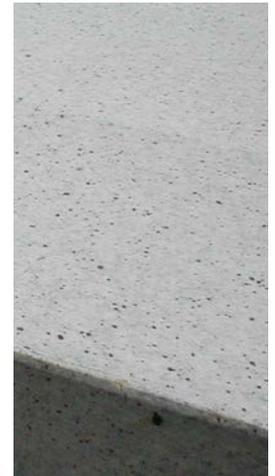
MODERN PHOTOGRAPH OF
TERRA COTTA IMITATION
OF GRANITE

In April 1913, the commission addressed the issue of exterior materials. As prescribed by the architect, the exterior walls would be formed with granite from the ground level to the top of the columns. The capitals, cornice, parapet and pediments were to be faced with terra cotta and the drum finished with cement plaster. The commission subsequently proposed the use of granite to the top of the parapet and pediments, authorizing an increased expenditure of \$324,000 for the extra granite. The commission also approved sectional, unpolished columns for the exterior but more expensive monolithic, polished marble columns for the interior.
